# Manhole Inspection Summary

Manhole # S51E\_\_016MH

Insp Date: **4/30/09 10:14 AM**

**Location** Address: **2900 E BALTIMORE ST**

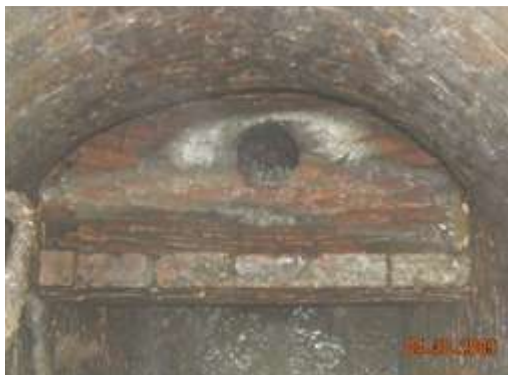
INVERTED TOP VIEW SHOWING  
CONNECTIVITY OF 3 AND 9 OCLOCK  
TO THE INSIDE DROP

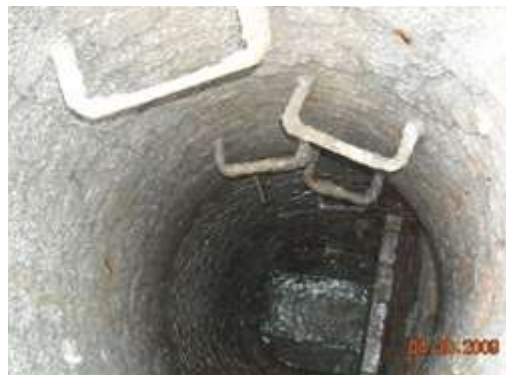
Defect 1

Count: **5** Missing: **6** ☒ **Corroded**

CORRODED AND MISSING STEPS

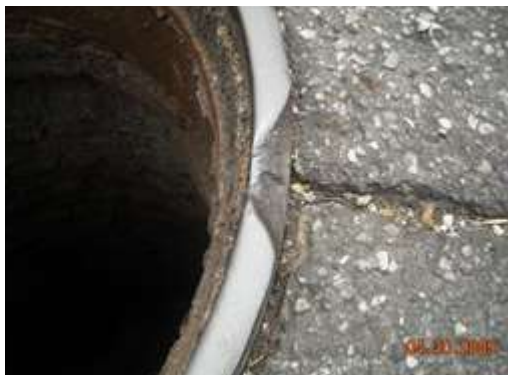
Defect 4

☒ **Cracked**

CRACKED/CHIPPED FRAME

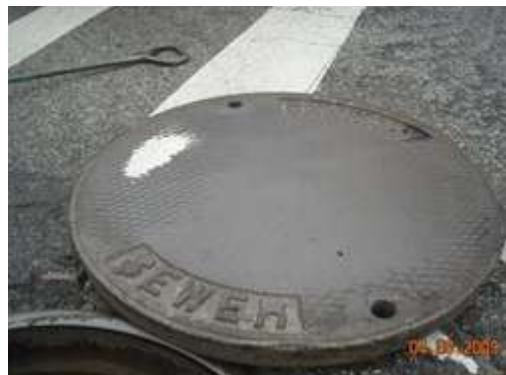
Defect 3

Condition: **Worn**

WORN COVER

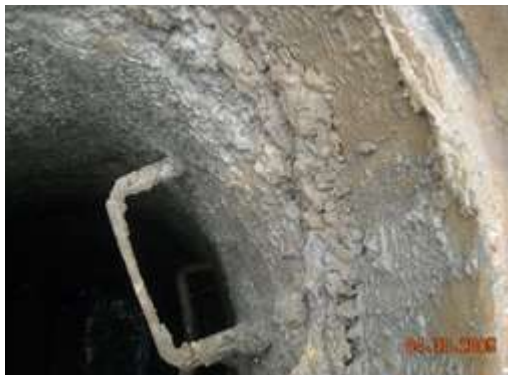
### Defect 2

Offset: **2** (in.)

☒ **Leaks**

Condition: ☐ Sound ☐ Cracked ☐ Root Intrusion ☐ Loose Brick ☒ **Deteriorated**

Infiltration: ☐ None ☒ **Joint** ☐ Cracks ☐ Mortar ☐ Roots ☐ Wall

FRAME OFFSET, FRAME  
INFILTRATION, DETERIORATED  
CHIMNEY, JOINT INFILTRATION

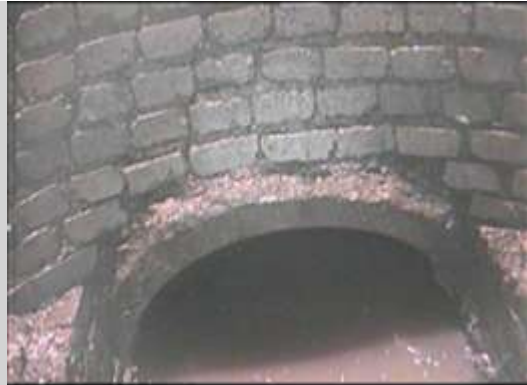
12 O'Clock Outflow

Pipe Height: **27.6** (in.) Rod and Bar (Angled)  
Pipe Material: **Unknown** ☐ Pipe Lined  
Invert Depth: **20.15** (ft.) Flow Characteristics: **Fast**  
Deposits: ☐ None ☒ **Mud** ☒ **Sludge** ☐ Debris ☐ Grease  
Silt Depth: **4** (in.) Deposits Extent: **Light**  
Infiltration: **None** Pipe Seal Cond: **Sound**

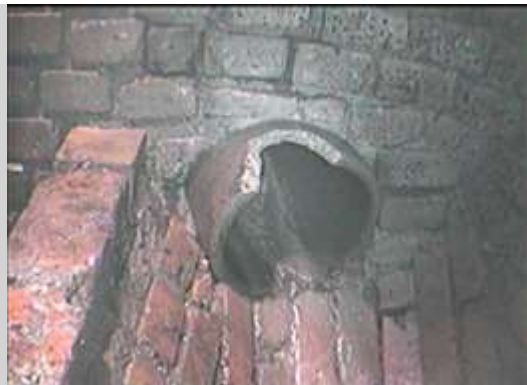
3 O'Clock Inflow

Pipe Height: **8.4** (in.) Rod and Bar (Angled)  
Pipe Material: **Clay** ☐ Pipe Lined  
Invert Depth: **11.40** (ft.) Flow Characteristics: **Slow**  
Deposits: ☒ None ☐ **Mud** ☐ **Sludge** ☐ Debris ☐ Grease  
Silt Depth: **0** (in.) Deposits Extent:  
Infiltration: **None** Pipe Seal Cond: **Sound**

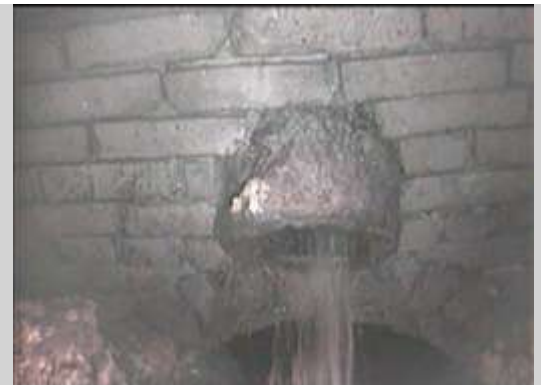
Drop In @ 3 O'Clock

Drop In for Pipe @ 3 and 9 is the same

Drop: **Inside** **Rod and Bar**  
Angled: **Yes** Reading: **16.86** (ft.)  
Inv Depth: **17.86** (ft.)  
Drop Condition: **Open**

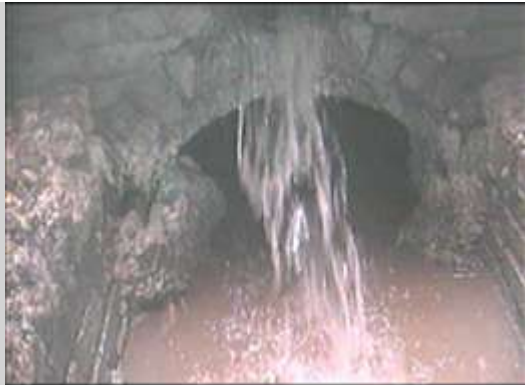
6 O'Clock Inflow

Deposits: ☐ None ☒ Mud ☒ Sludge ☐ Debris ☒ Grease

Silt Depth: **8** (in.) Deposits Extent: **Heavy**

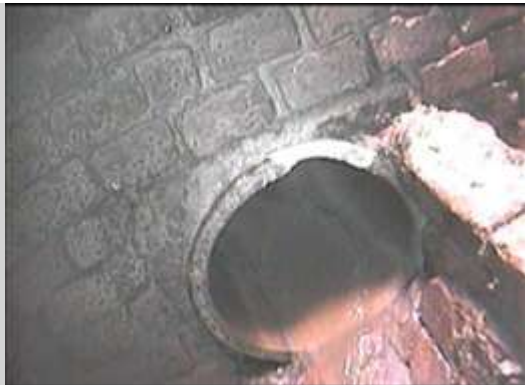
9 O'Clock Inflow

Pipe Height: **9.6** (in.) Rod and Bar (Angled)

Invert Depth: **11.80** (ft.) Flow Characteristics: **Slow**

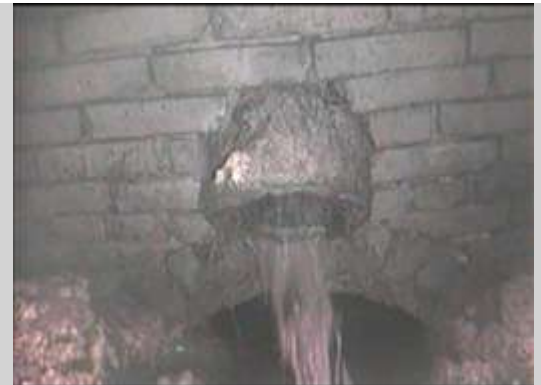
Drop In @ 9 O'Clock

Drop In for Pipe @ 3 and 9 is the same

Drop Condition: **Open**
